N73-15042
NASA TM X-2671

**HIGH-ALTITUDE FLIGHT TEST
OF A DISK-GAP-BAND PARACHUTE
DEPLOYED BEHIND A BLUFF BODY
AT A MACH NUMBER OF 2.69**

by Clinton V. Eckstrom and Darrell R. Branscome

Langley Research Center

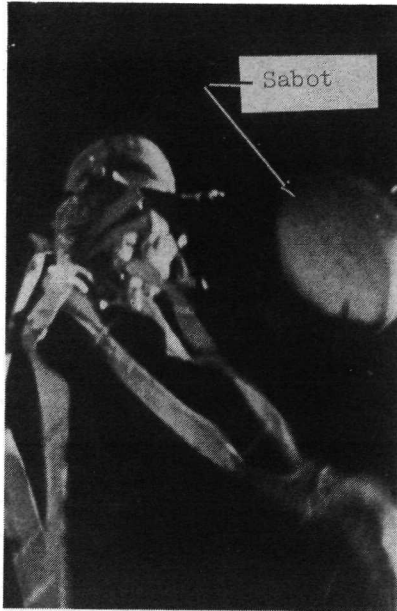
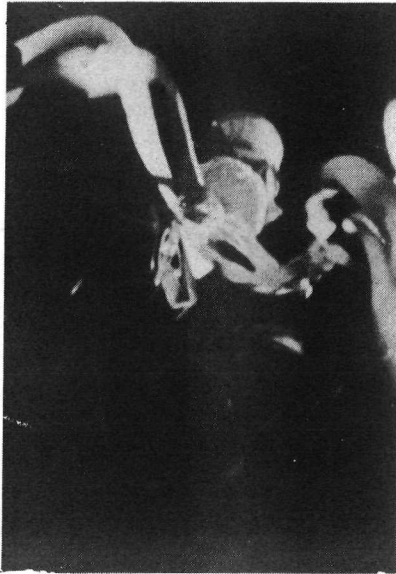
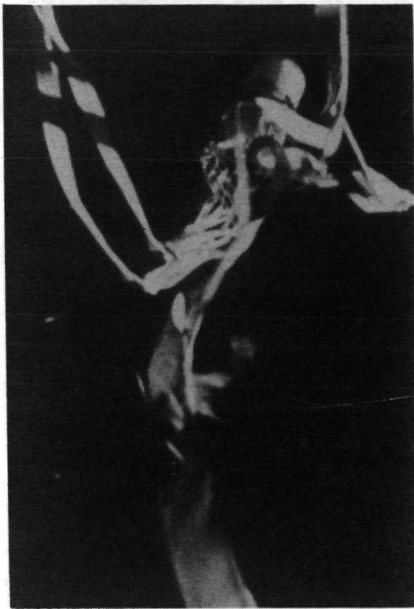
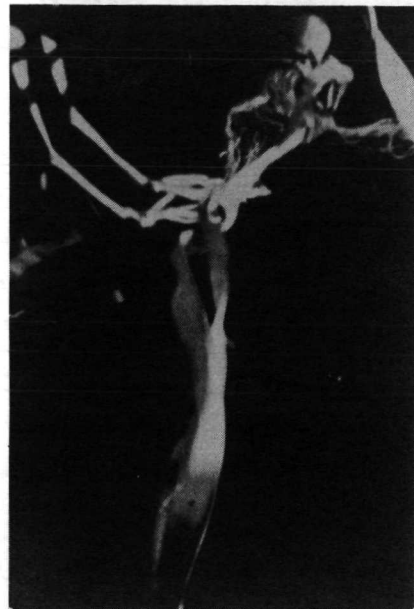
L-72-6590

(a) Parachute pack ejection.

Figure 18.- Onboard camera photographs.

Parachute inflation.- Selected frames from the aft-camera film showing the initial stages of parachute deployment, inflation, shape distortions, and damage propagation sequences are presented in figure 18.
